Parbuckle salvage

Parbuckle salvage, or ***parbuckling***, is the righting of a sunken vessel using rotational leverage. A common operation with smaller [watercraft](#), parbuckling is also employed to right large vessels. In 1943 *USS Oklahoma* was rotated nearly 180 degrees to upright after being sunk in the [attack on Pearl Harbor](#), and the Italian cruise ship *Costa Concordia* was successfully parbuckled off the west coast of Italy in September 2013, the largest salvage operation of that kind to date.

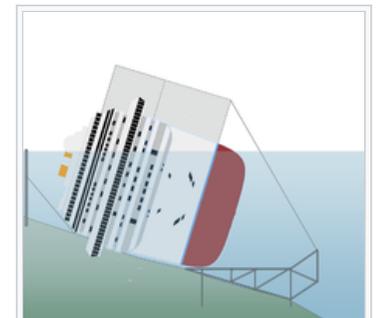
Costa Concordia parbuckling diagram: In this view looking north (facing bow), chains are on the left of the image (starboard side of ship, facing the coast), sponsons and cables on right side of the image (port side of the ship, facing deeper water). Not shown are the grout pads between the seabed and the platforms.

The holdback system consisted of 56 chains in total, of which 22 chains were attached to the port side to go under the hull to the island. Each chain was 58 meters (190 ft) long and weighed about 26 metric tons (29 short tons).^[5] Each link weighed 205 kilograms (452 pounds).

The ledge was part steel and part grout. There were six steel platforms. The three larger platforms measured 35 by 40 meters (115 by 131 feet) each; the three smaller platforms measured 15 by 5 meters (49 by 16 feet) each. The 6 platforms were supported by 21 pillars of 1.6 meters (5.2 feet) diameter each and plunged for an average of 9 meters (30 feet) in the granite sea face

Eleven steel sponsons were installed on the port side of the hull: two long horizontal sponsons; two long vertical sponsons and seven short vertical sponsons.

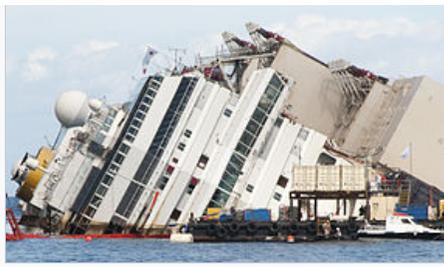
Operation in progress

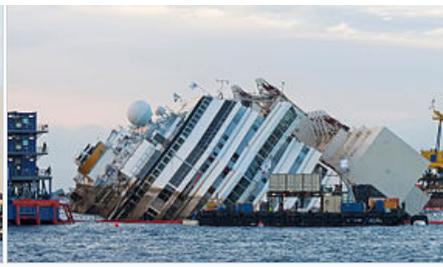
The operation continues but very slowly, at less than 2 degrees per hour

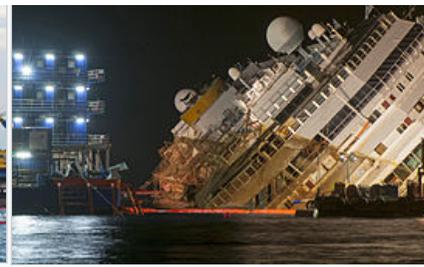
Sponsons are ready to fill with sea water, nearing 24 degrees of rotation.

The hull continued to rotate, pulled down by the weight of seawater added to the sponsons. The strand jacks and cables went slack. Redundant systems were designed as a guard against failure. For example, two seawater inlet valves were provided to each sponson.^[5]

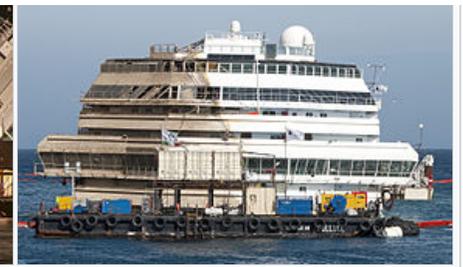
After the parbuckling

At the completion of parbuckling, *Costa Concordia* rested on the ledge at a depth of 30 meters (98 feet).^[5]

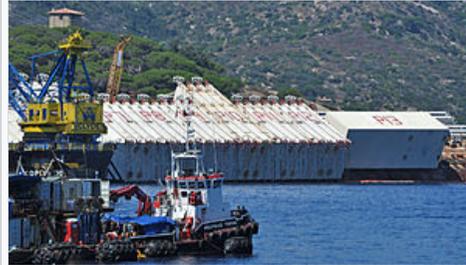
Port side with [sponsons](#) before righting

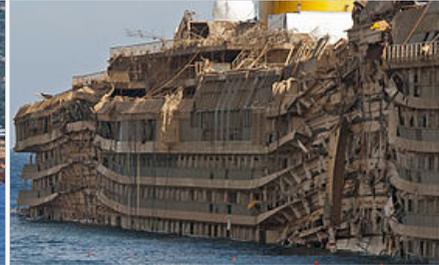
Crushed starboard side of the righted ship

The hull of *Costa Concordia* rested on two spurs of rock, and was severely deformed from the weight of the ship pressing down on the spurs. This phase began when the strand jacks exerted force and the ship started to return to an upright position. This was "without doubt one of the most delicate phases of the entire recovery plan."^[5]
